#### **FAILURE ANALYSIS** A Guide to Analyzing Axial Piston Pump Failures

Oilgear Company Milwaukee, USA

80-776, Rev. 4/05

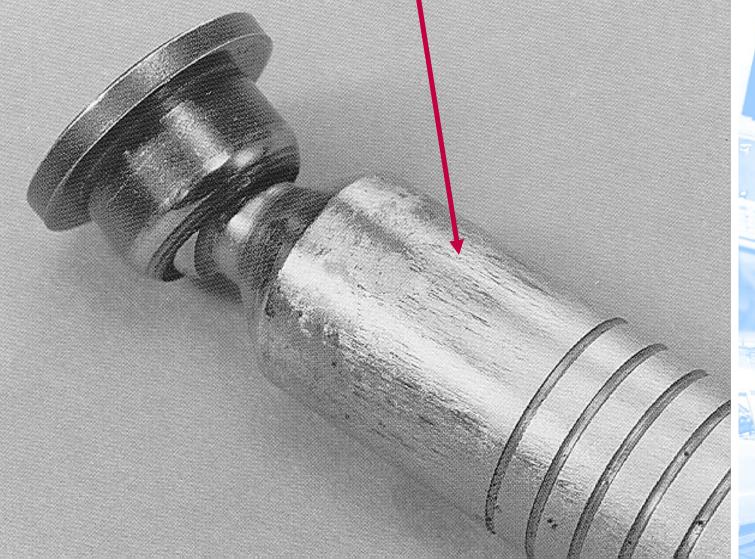
### PISTON THAT SEIZED IN BORE

#### Note Metal Transfer

# **VERTICAL SCRATCHES:** Official of Contamination

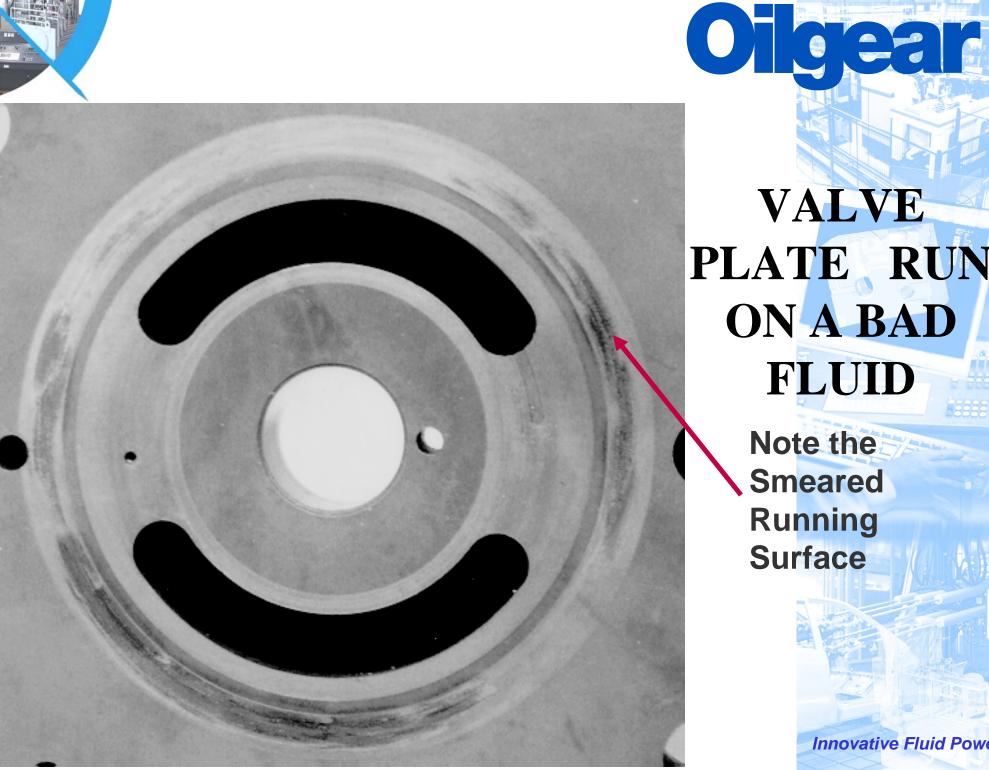
#### VALVE PLATE RUN **ON A BAD FLUID**

Note the Smeared Running Surface

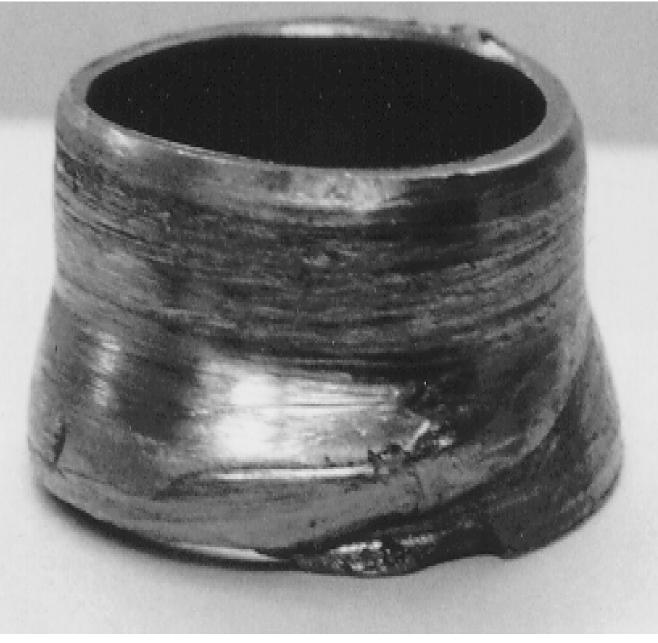
OIGEAGE WORN FULCRUM BALL

> Typical Failure on Low Lubricity Fluid

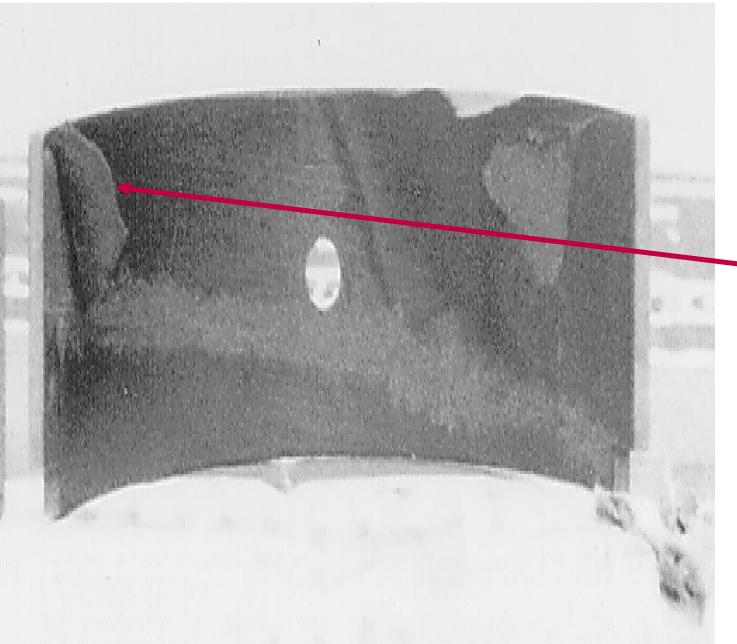
### Oigear WORN SADDLE BEARING

Note the Material has Delaminated

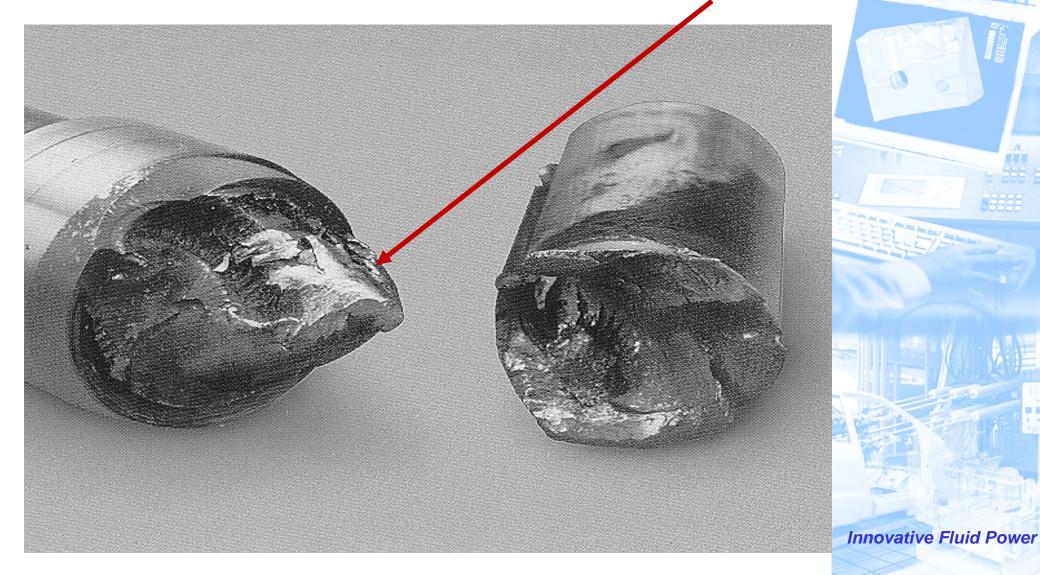
# TORSIONAL FATIGUE

**Note Cone Shaped Failure**

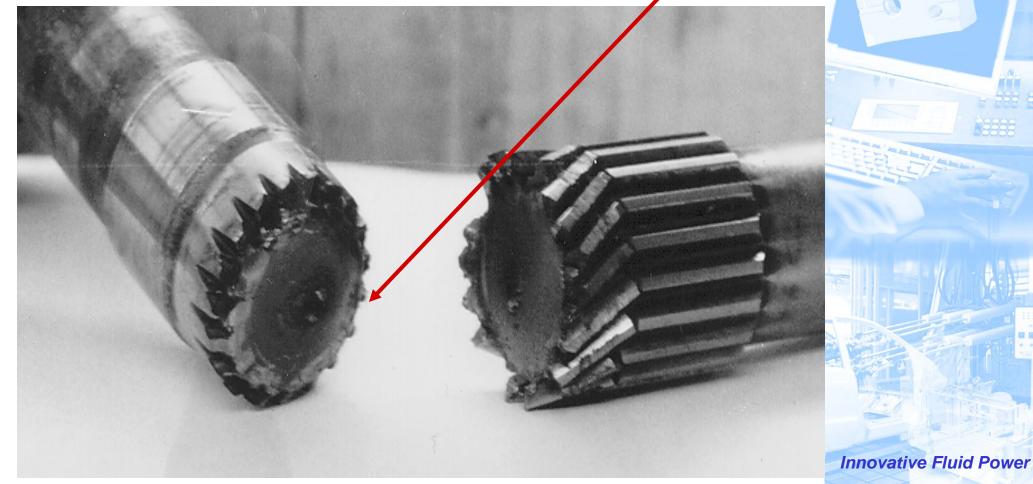
# BENDING FATIGUE FAILURE

Note Straight Break

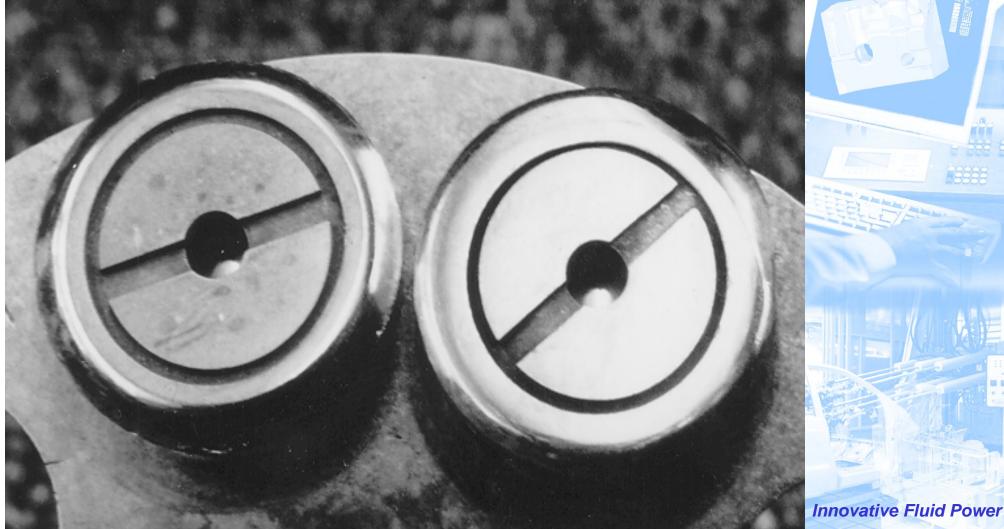
# **ROLLED SHOES: THE TELL** TALE OF SHOE LIFT

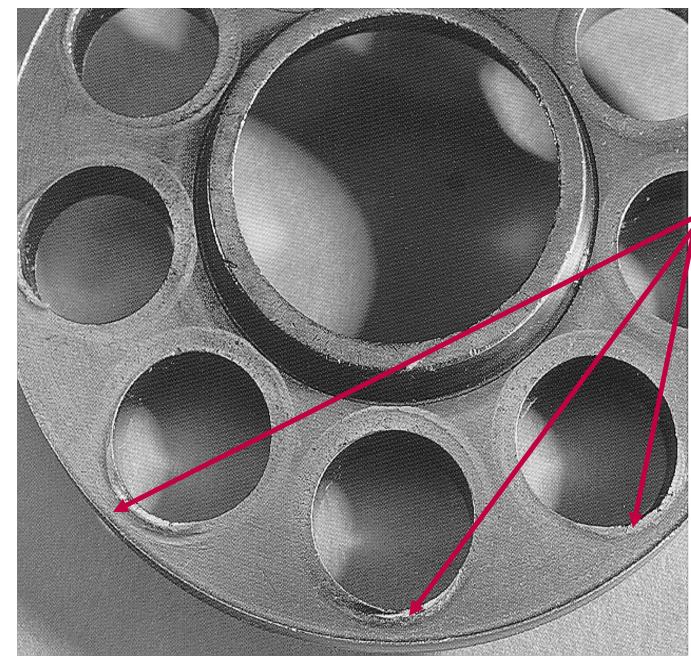
### Oigear WEAR ON SHOE RETAINER FROM **SHOE** FLANGES

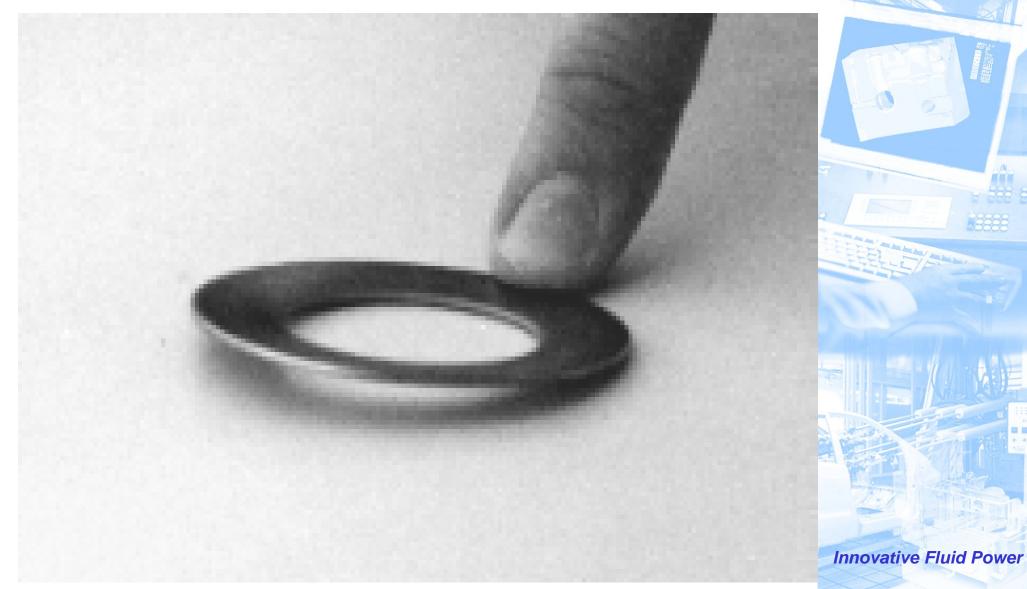
# **BENT SEAL RETAINER**
