Repair-N-Place Instructions

Long Reach's patented "Repair-In-Place" design features the streamlined replacement of the polymer wear strips found on most of our lateral clamp series and LDS bodies.

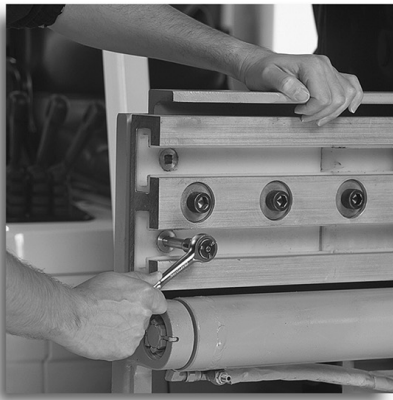
- 1** Remove the outer plugs on one side with a 3/8" ratchet. It may take a bit of effort since the plugs are torqued down to approximately 50 ft. lbs. and Loc-Tite® is installed at the factory.

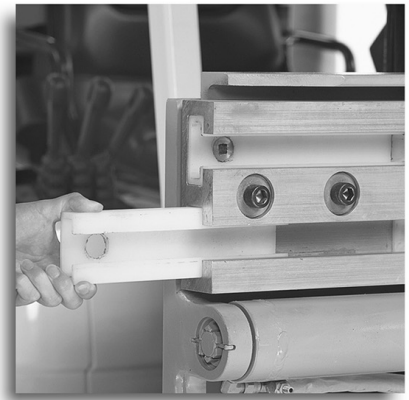
- 3** Once all the plugs have been removed, lower attachment to remove weight on arms and slide out both old outer wear strip pieces by hand. They slide out with little effort. Keep the long center wear strip in place for now.

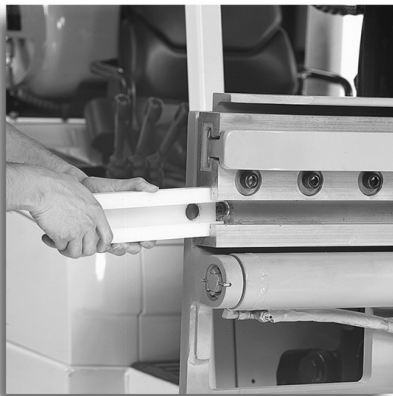
- 4** Pick a side. Insert the opposite side new outer strip into the channel by hand or by tapping with a rubber or leather mallet.

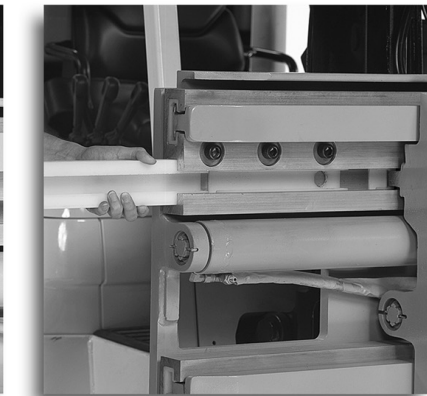
- 5** Next, tap in the new, long center wear strip. Continue to drive both new wear strips into the channel until they push out and replace the old, long center wear strip.

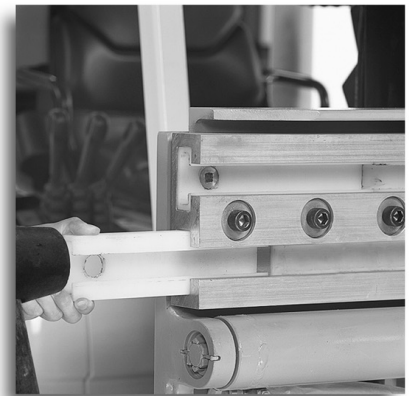
- 6** Using the mallet, tap in the final new, outer piece and reinstall the plugs with mild (blue grade) 242 Loc-Tite®. Finally, torque the retainer plugs to 50 ft. lbs. and you're finished.
