# Increased Safety!

## Broken Steering Arm?

Improved design reduces steering arm failure at the cylinder pin.

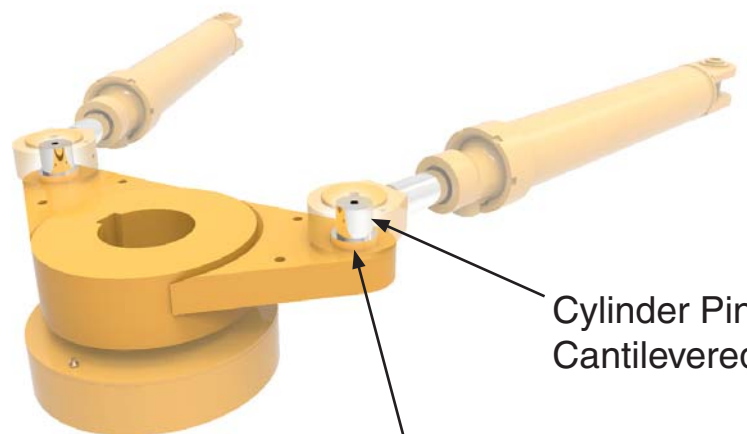
### Old Design

Customers routinely reweld old design. Cantilevered pins will **break** loose again and again.

Have you experienced a failure of the steering arm at the cylinder pin? This may be caused by the cantilevered design.

544649  
522072

Stop rewelding the pin!

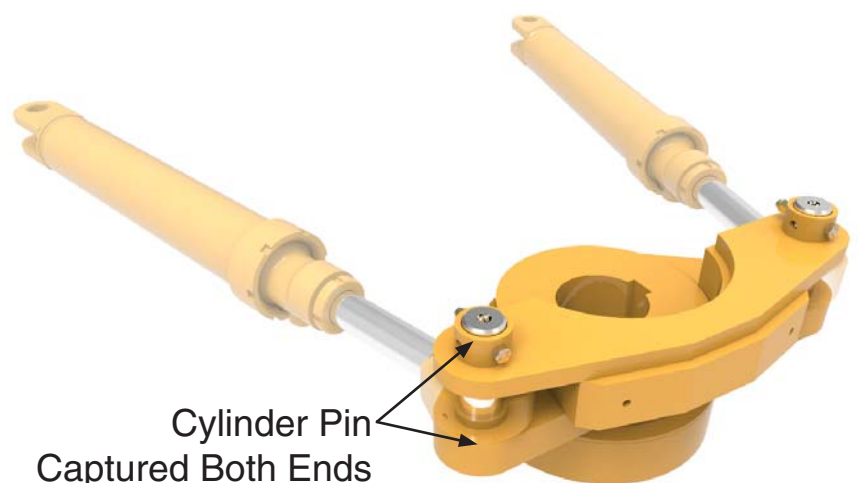
### New Design

A new steering arm (PN 591240) captures the cylinder pin on both ends, reducing the chance of failure. And the best part is that the new design drops right in with no rework necessary.

591240

Part Number	Description	QTY
591240	Steering Arm	1
565013	Cylinder Pins	2
R13811083	Capscrews	2
R13811193	Nuts	2
