#### **FAILURE ANALYSIS** A Guide to Analyzing Axial Piston Pump Failures

Oilgear Company Milwaukee, USA

80-776, Rev. 4/05

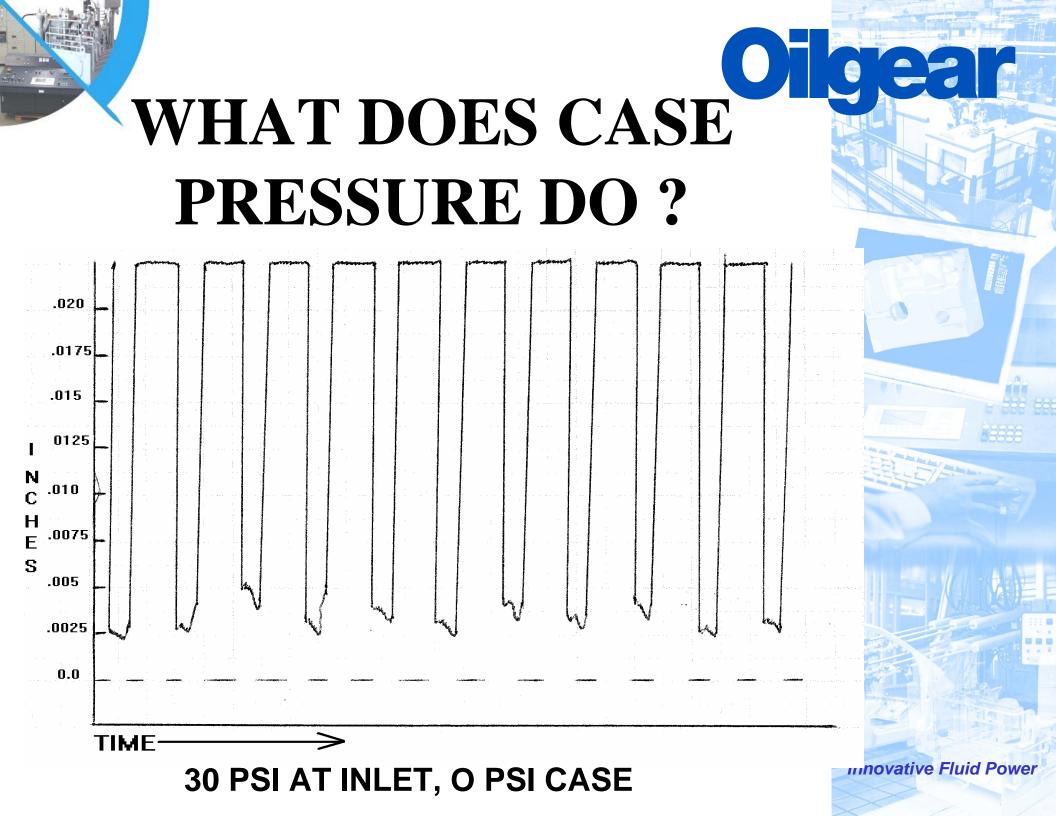
# **CASE TO INLET DIFFERENTIAL**

- In General Differential Cannot Exceed 10 PSI
  - SHOE EDGES ROUNDED
  - SHOES LOOSE ON BALLS
  - SWASHBLOCK WEAR, HALF MOON SHAPE
  - EXCESSIVE WEAR ON BACK OF SHOE FLANGES
  - SEAL RETAINER BENT
