## **DUO-CONE SEAL INSTALLATION**

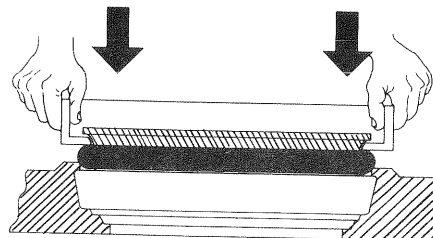
### STEP -4-

Set seal ring with toric squarely on the seal housing. **APPLY** sudden pressure to pop toric under housing retaining lip.

Toric can twist if it is dry on one spot or if there are burrs or fins on the housing retaining lip.

A bulging toric or cocked seal can contribute to eventual failure.

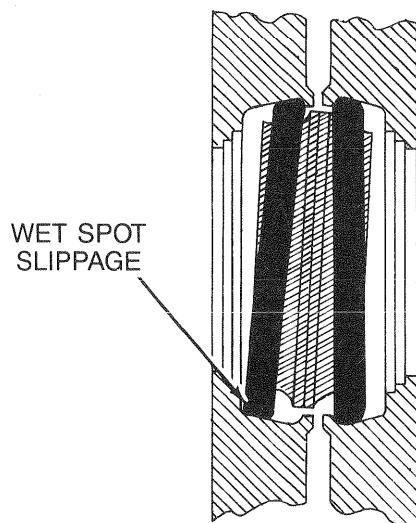
#### BEFORE ASSEMBLING BOTH SEALS AND HOUSING TOGETHER...

**WAIT**—at least two minutes to let all Tri-Chloroethane evaporate (some may still be trapped between toric and housing ramp).

1. A wet spot between housing and ramp can cause sliding and cock the seal.
2. Cocked seals cause uneven pressure on the seal face and it can cause the seal to wobble.
3. Uneven pressure causes leakage or scoring.
4. Wobbling seals can cause dirt entry problems in the field.

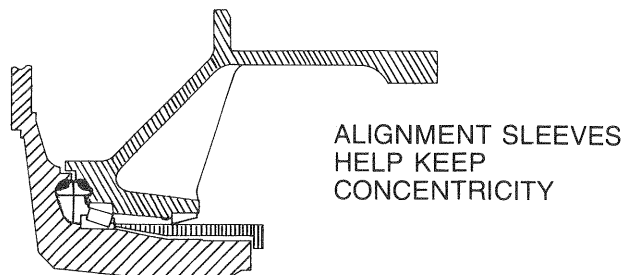
### STEP -7-

Assemble both housings and seal rings together. **MAKE SURE THEY ARE SQUARE AND CONCENTRIC.**

Bring seals together slowly and carefully. Slamming can damage or break seal on impact.

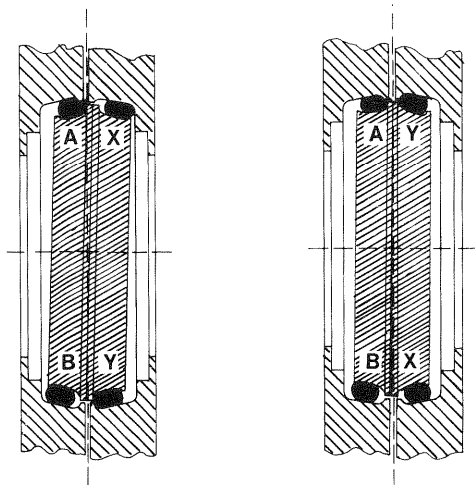
## RESULTS OF INCORRECT ASSEMBLY

Points "A" and "B" remain stationary. Points "X" and "Y" rotate 180°. This causes high pressure at "A" and "Y" and possible galling.

ORIGINAL  
"AS ASSEMBLED"  
POSITION

ROTATED 180° FROM  
"ORIGINAL" POSITION

Whereas at "B" and "X" there is low pressure and possible leakage.
